CONDITION ASSESSMENT AND RECOMMENDATIONS

Butler-Perozzi Fountain

Lithia Park

Ashland Parks Foundation | July 26, 2022, Rev. 01 October 05 2022

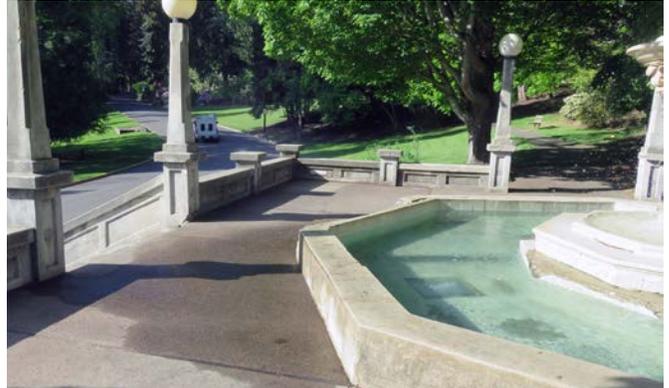
Water splashes out of the east end of the fountain, at the top of the stairs.

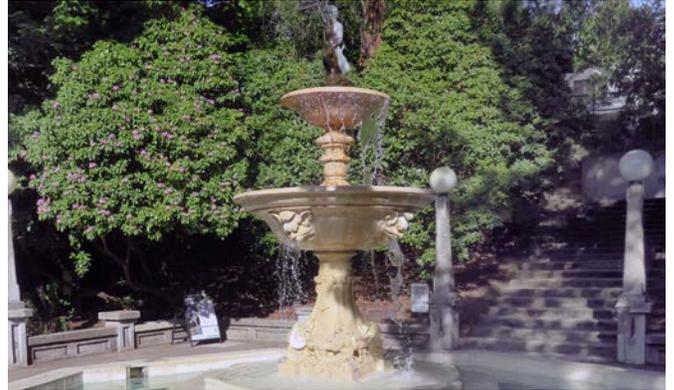
Water flows unevenly off the north east edges of the bowls. Note that the flow out of the lions is not smooth.

- The middle bowl is in fair condition. It appears to be original and shows some uneven wear on the east edge of the bowl, likely related to the flow issues in the fountain. Water was likely meant to flow to the lower bowl through the open mouths of the lion's heads on the underside of the bowl. Currently, the flow out these areas is uneven and may be related to water pressure/flow issues, or blockages in the openings.

- Water flow issues should be addressed. Blockages should be cleared so that water flows evenly out of the lion's heads on the middle bowl rather than over the rim of the middle bowl. This will prevent uneven wear and erosion on the rim. Openings could be re-drilled, and brass escutcheons installed to direct the flow downward to minimize the erosive effects of splashing on the lower pedestal.

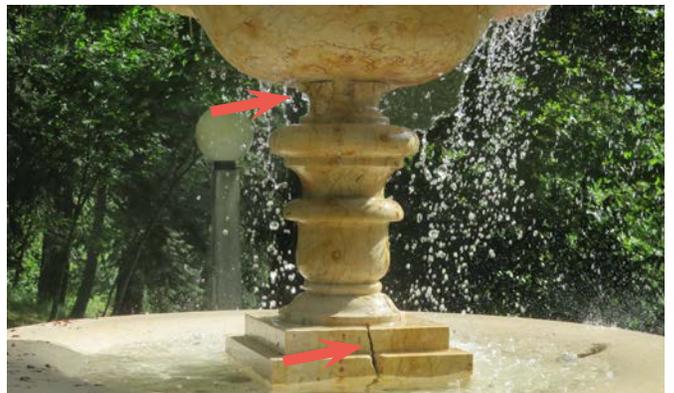
- The pedestal supporting the upper bowl is in poor condition. It has spalls at the upper and lower lips, and a through-unit crack in its base. Although it could not

Cracks and spalls at the upper pedestal.

- The pedestal supporting the upper bowl is in poor condition and should be replaced. The noted conditions affect the structural stability of this unit, and the upper bowl has been known to rock. Should it fall, this poses a significant risk to the upper bowl itself and to the lower elements of the fountain as would impact them when toppled. As these elements are replacements, they should be replaced in kind. Historic photos may be used to achieve a level of detail more consistent with the original pedestal.

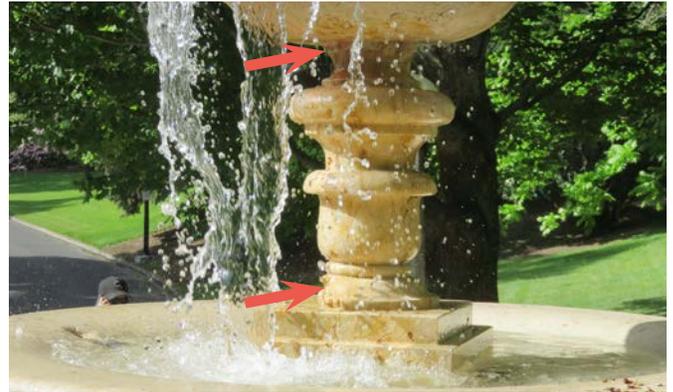
Spalls at the upper pedestal.

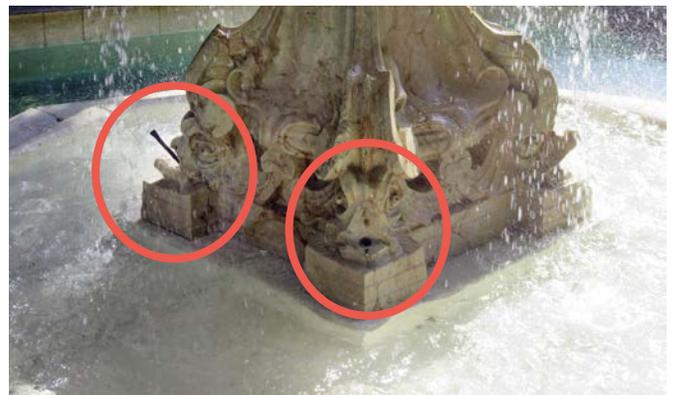
- Two of the gargoyles at the lower pedestal are in poor condition. Two are missing most of their faces. One of these has a piece of piping sticking out of its mouth. This appears to have been a recent attempt at vandalism. It should be noted that water still flows from this spout. The other that is missing its face no longer spits water. These two gargoyles may have been repaired in the 1987 restoration, but these repairs have failed.

Damaged gargoyles at lower pedestal. Note the pipe sticking out of the element on the left.

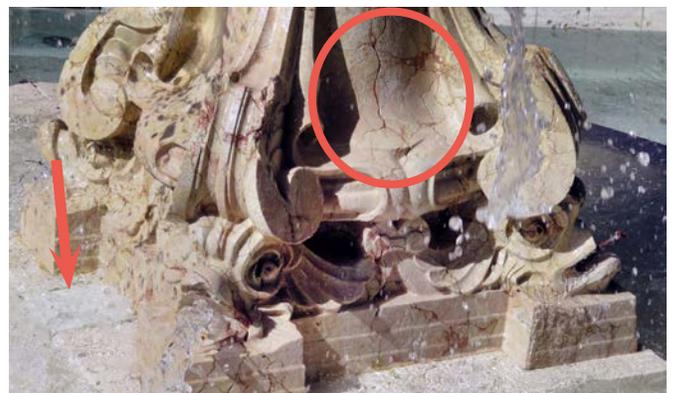
- The lower pedestal is in fair to poor condition, with spalls, uneven weathering, and flow issues. While most spalls are superficial and occur around the scrolls around the spitting gargoyles, two gargoyles show significant loss of their facial features. The valves or other mechanisms that control flow to the gargoyles was not detected. It is possible that these connections are broken and contributing to water flow that emanates from various joints and cracks in the lower pedestal.

Weathered veining in lower pedestal. Note the dutchman repair indicated with an arrow.

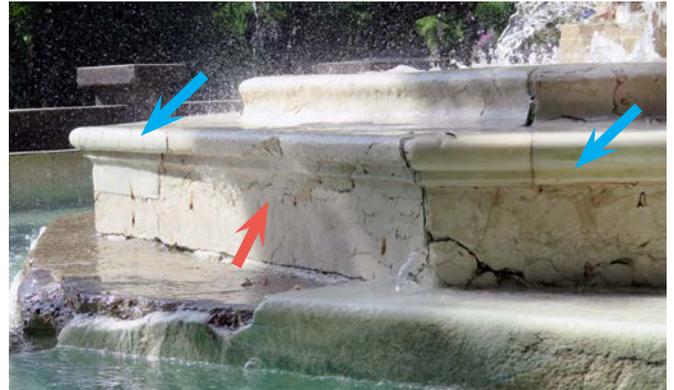
- There are several rounds of repair on the lower bowl, including epoxy repairs and dutchman repairs. The epoxy repairs are in poor condition, as the marble around the repairs has continued to weather, resulting in slightly raised patches. The condition of the dutchman repairs varies. While most are still in good condition there are isolated areas of failed joints that should be repaired. Water flows from various joints and gaps in the lower bowl. Its origin could include gaps between the upper structure or via water conveyance through a cylindrical chase that typically contains the piping that delivers water to the upper portions of the assembly.

Crack (red) and dutchman repairs (blue) in lower bowl. Note the open joint between the plaster and the marble.

- Cracks and spalls in the lower bowl should be repaired. The previous dutchman repairs should be repointed as needed. Large areas of missing or spalled material should be replaced in kind with a dutchman repair. Existing joints and carved features should be accurately replicated.

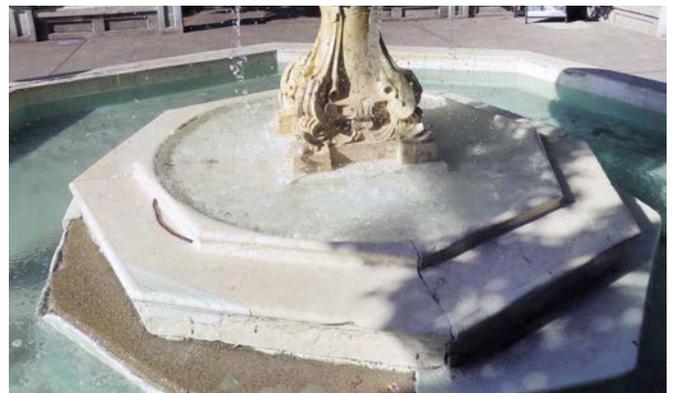
- The lower bowl is in fair condition. While the marble is in fair condition, the joints between the bowl sections are in very poor condition. They are heavily eroded and missing in large areas. This likely contributes to water loss and flow issues at the fountain.

Previous repairs and open joints at lower bowl. Note the plaster failure and exposed concrete at the bottom right.

- The joints, especially those in the lower bowl, should be repaired. A tile grout appropriate for marble and partially submerged conditions should be used.

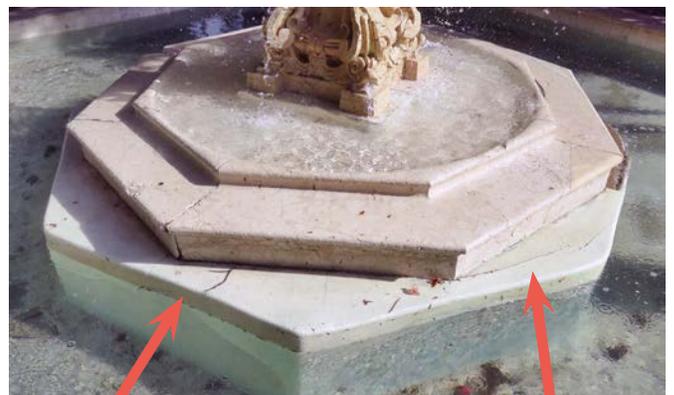
- The pool of the fountain is in poor condition, with large areas of cracked and missing swimming pool plaster. The plaster shows signs of previous patching, and many of the interfaces of these patches have failed and exhibit large cracks. Some of the pool plaster extends above the waterline onto the lower podium and has experienced significant delamination. In general, pool plaster should be continually submerged as it can dry out, check, crack, and fall apart. Hence, if a fountain is to be drained in the wintertime or experiences periods with no water such as shutdowns during extreme drought conditions, swimming pool plaster is a poor choice if lining material.

Cracks in plaster over concrete base.

- The lower pool and outer rim of the fountain pool should be demolished and replaced. Historic photographs indicate that this wall has long had water issues and the plaster and tile installation is both prone to failure and is non-historic. There are multiple failed repairs and corroding reinforcement. Furthermore, the installation of new piping and reliable

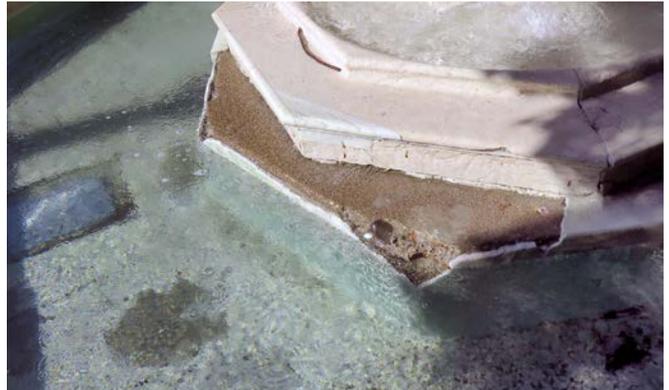
Plaster loss at concrete base. Note plaster loss below the water, on the floor of the pool.

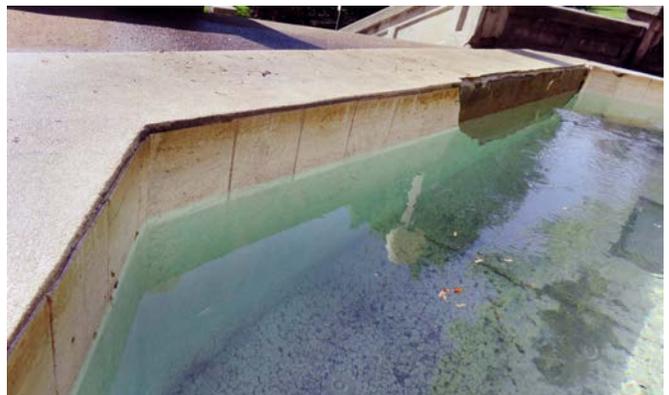
- The tile line at the outer edge of the pool is in fair to poor condition. There is a large area of missing tiles at the east side of the fountain, and the tiles are weathered and stained. A tile band is a necessary feature to maintain a submerged condition for the pool plaster and to provide a smooth surface for cleaning scum that tends to accumulate at the waterline.. Based on historic photos, this tile line was added in the 1987 restoration.

Missing and soiled perimeter tiles.

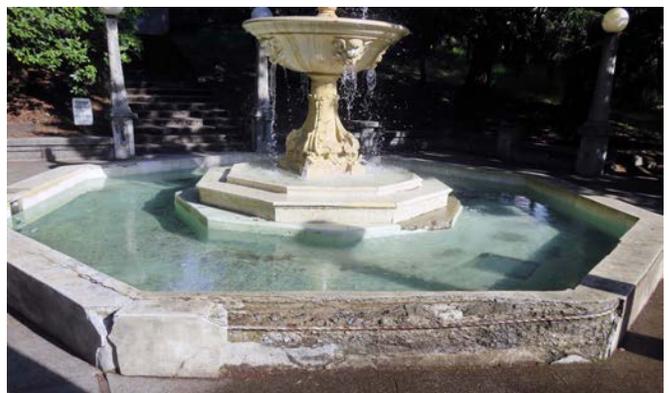
- The outer rim of the pool is in poor condition, with a large area of loss and exposed ferrous reinforcement at the east side of the fountain. This appears to have been a recurring problem area, as there are signs of at least four repair campaigns. Additionally, based on historic photos the outer rim was made thicker and taller in the 1987 restoration, likely in response to water issues at this wall. The delamination issues at this wall suggest that it is another avenue for water to escape the fountain system.

Concrete loss at outer rim of fountain pool.

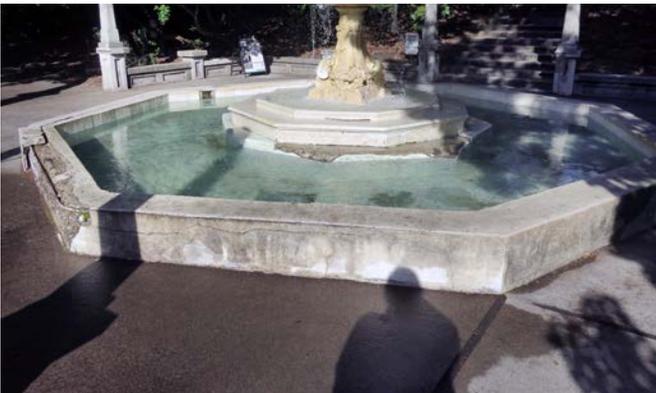
Concrete cracking, spalls, and soiling at outer rim of fountain pool.

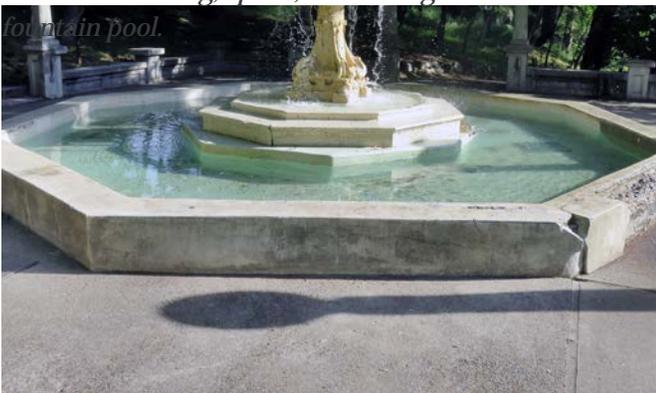
Concrete cracking, spalls, and soiling at outer rim of fountain pool.

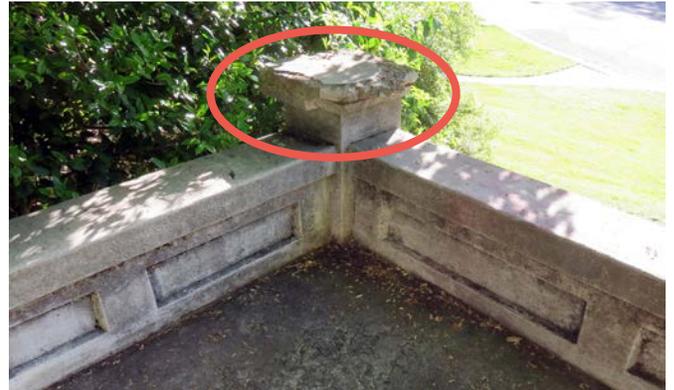
- Several of the column capitals are in poor condition, with corrosion of the embedded ferrous reinforcement. This has caused delamination of the surface finish, cracking, and spalling. In some locations the ferrous reinforcement has been exposed. Many of these areas show signs of previous repair.

Concrete cracking, spalls, and soiling at terrace column.

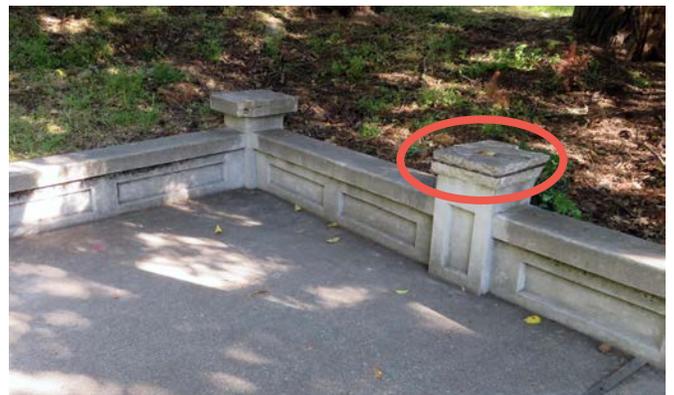
Concrete cracking, spalls, and soiling at terrace columns.

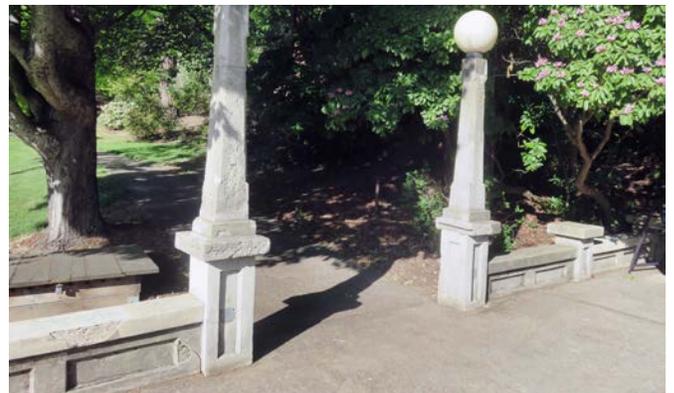
- The light posts are in good to poor condition. They exhibit similar signs of deterioration to the column capitals with delamination of the surface finish, cracking, and spalling. There are also areas of exposed ferrous reinforcement, and signs of previous repair.

Concrete cracking, spalls, and soiling at light posts.

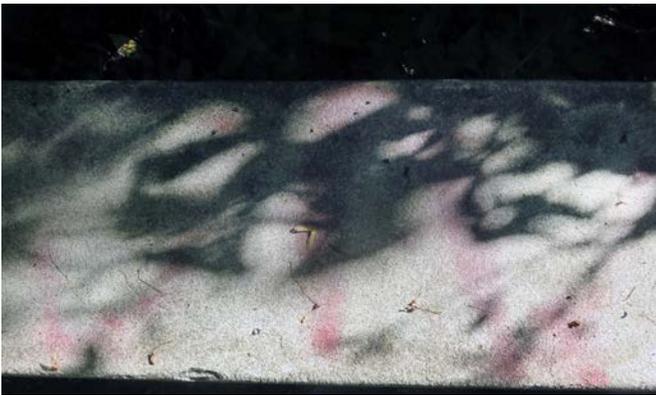
- There are several areas of graffiti ghosting on the skyward face of the concrete walls. The graffiti has been mostly removed but some residual color is still visible on the concrete.

Graffiti ghosting on terrace wall.

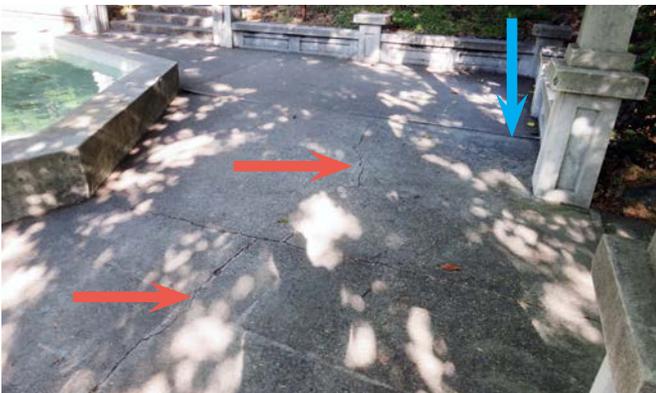
- The flat concrete is in fair condition, with cracking and surface loss on the north end.
- The flat paving has inset wood strips. These strips are beginning to warp in some areas due to moisture in the wood.

Concrete cracks (red) and warped wood strips in terrace floor (blue).

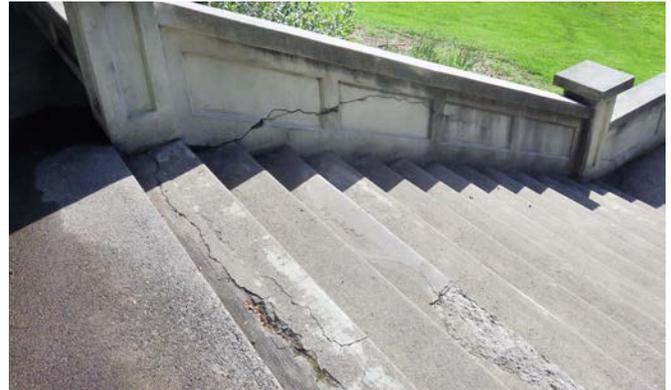
Cracks in cheek wall and failed repairs and cracks in the stairs.

- Spalls and cracks on the stair treads should be repaired. Failed repairs should be removed and replaced.

- Cracks in the cheek walls should be routed and repaired. Care should be taken to match the existing color and texture.
- The concrete should be cleaned using a biodegradable, non-acidic cleaner and low-pressure power washer. In order to prevent streaking and wand marks, a distance of at least 6 inches should be maintained between the surface and the tip of the power wash wand equipped with a fan tip 60 degrees or greater.
- While not included in the scope of this project, as it is not a signed or publicized pathway, the staircase from Granite Street should be studied for accessibility, and a handrail should be added if needed.

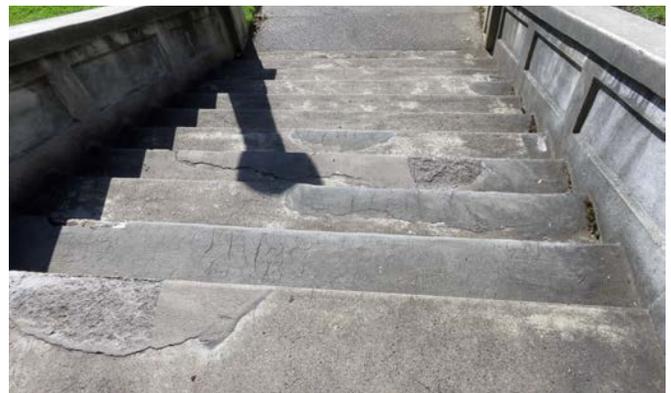
Uneven and failed repairs at the lower stairs.

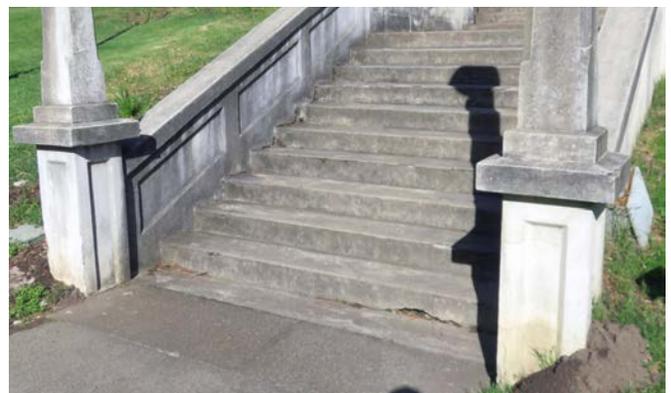
Failed repairs and small spalls at lower stairs.
