CONDITION ASSESSMENT AND RECOMMENDATIONS

Butler-Perozzi Fountain

Lithia Park

Ashland Parks Foundation | July 26, 2022, Rev. 01 October 05 2022

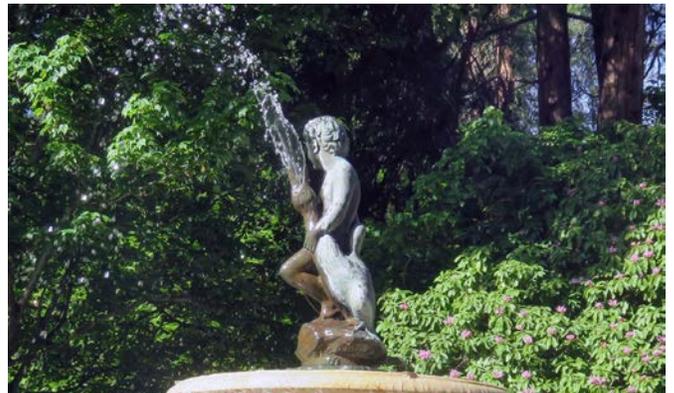
- The bronze statue at the top of the fountain is a replica of the original marble statue and was installed in the 1987 restoration. The bronze is in fair condition and is showing signs of cupric oxidation; it is turning green in some areas whereas the rest of the statue has a typical brown patina. The bronze should be cleaned and given a waterproof protective coating to prevent oxidation.

Bronze discoloration at the fountain's statue.

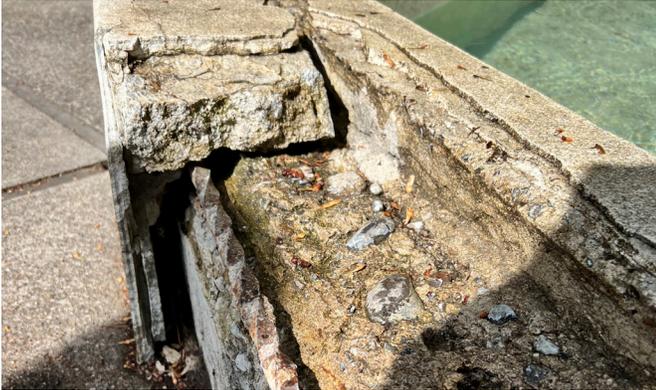
- At the fountain pool outer edge, perimeter terrace walls, and light posts, spalled concrete has revealed embedded ferrous reinforcement. In some areas the exposed reinforcement is corroding and causing further deterioration.

Concrete cracking, spalls, and soiling at outer rim of fountain pool.

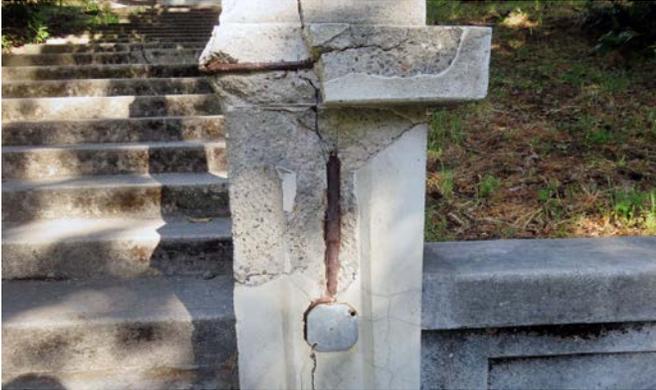
Concrete cracking and spalls at light post.

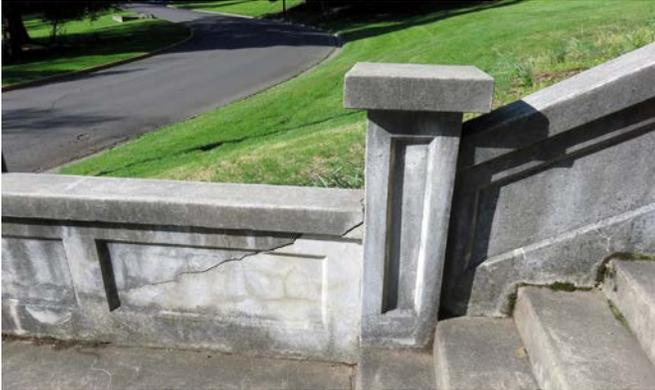
Cracks in the cheek wall. This crack is also visible at the exterior face.

- Cracks in the cheek walls should be routed and repaired. Care should be taken to match the existing color and texture.
- The concrete should be cleaned using a biodegradable, non-acidic cleaner and low-pressure power washer. In order to prevent streaking and wand marks, a distance of at least 6 inches should be maintained between the surface and the tip of the power wash wand equipped with a fan tip 60 degrees or greater.
- While not included in the scope of this project, as it is not a signed or publicized pathway, the staircase from Granite Street should be studied for accessibility, and a handrail should be added if needed.

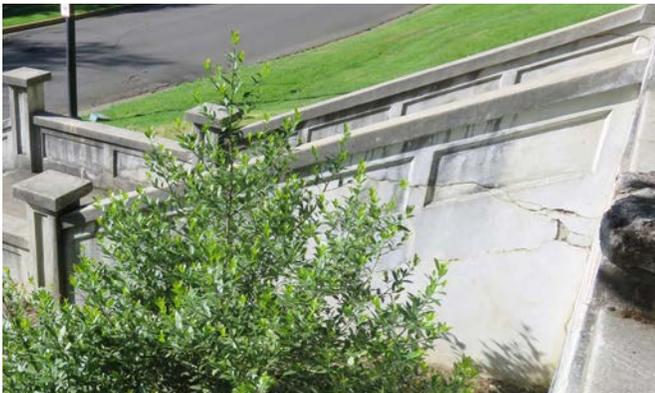
Cracks in the outer face of the staircase. This crack is also visible at the interior face.

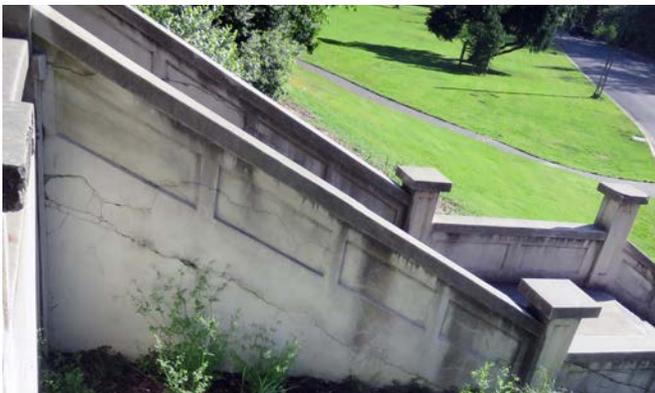
Cracks in the outer face of the staircase.
